# Analysis on Building Seismic Damage in the Wenchuan Earthquake

Ye Lieping, Lu Xinzheng, Qu Zhe, Feng Peng

Department of Civil Engineering, Tsinghua University, Beijing 10084 China

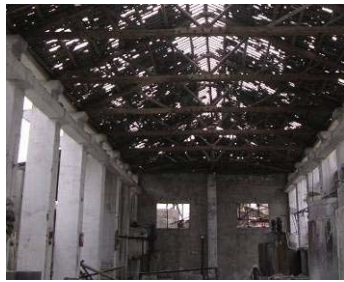
A factory in Anxian

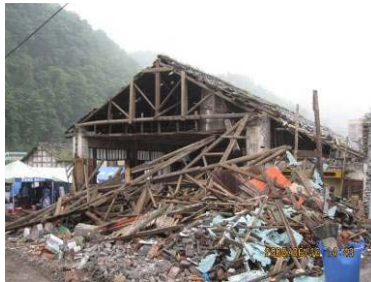
A folk house in Yinghua

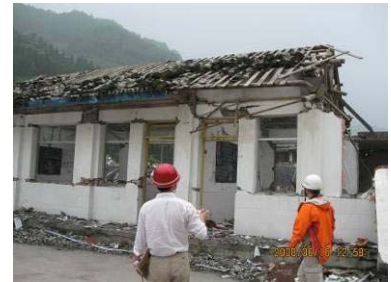
Fig. 1 Seismic damage of masonry structures with timber roof

This type of structure is widely used in single-story factories, warehouses and residential houses in the rural area for its cheap materials. These buildings are usually old and lack of maintenance. The strength of most of their masonry walls and columns can not meet the requirements of current building codes. They are

vulnerable to overall and partial collapse in the earthquake. See Figure 1.

The classroom of Hongbai Middleschool

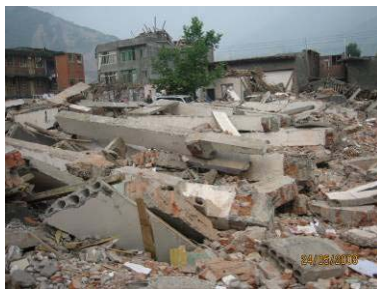
Collapse of the teaching building of Nanba primary school, Nanba

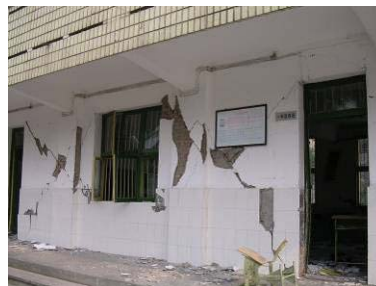
Severe damage in the load-bearing walls and columns of the teaching building of Huayuan St. Middle School, Jiangyou

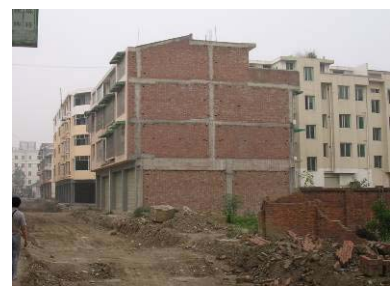
Fig.2 Seismic damage of RC-strengthened masonry structures

Most residential buildings, school buildings in the rural area, and some of factories, old residential and office buildings in the cities use the reinforced masonry structures, which is the most common structure type in the earthquake area. A lot of buildings of this structure type collapsed or were heavily damaged in the earthquake. Some general reasons of its vulnerability are: poor redundancy of structural system, lack of concrete structural columns and ring beams, poor connections of pre-cast slabs and so on. Figure 2 shows some typical damages of such structures. Some undamaged or slightly damaged buildings with this structure type could also be seen in the meizoseismal area. This proved that buildings with this structure type are able to survive the great earthquake only if the earthquake-resistant measures such as concrete structural columns and ring beams are ensured. To enhance the wholeness and lateral resistance is the key issue in the design of such structures.

Undamaged masonry structures with concrete structural columns and ring beams in Anxian

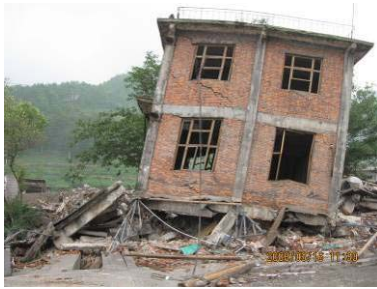
A gas station using masonry structure with bottom RC frame, Hongbai

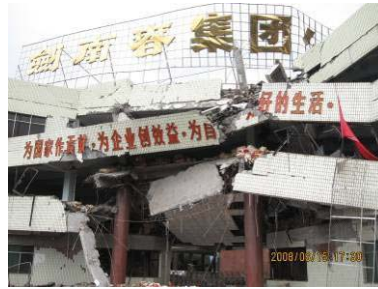
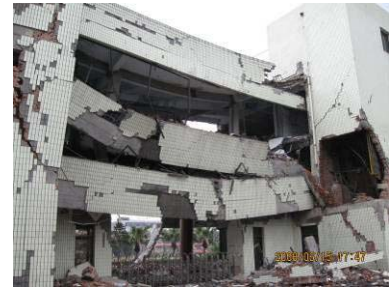
Fig.3 Seismic damage of RC frame-masonry hybrid structures

There're many hybrid layouts including vertical hybrid such as masonry structures with bottom RC frames, and horizontal hybrid structure with partial RC frames and partial masonry structures. The load-bearing system, especially the lateral load-resistant systems of these structures are generally disordered and inconsistent in deformation between different parts. The vertical or horizontal stiffness of most of these structures is also badly distributed. Some common damages of these structures are: weak story collapse and the collapse of upside masonry structures. See Figure 3.

The damage of an office building using horizontal hybrid structure

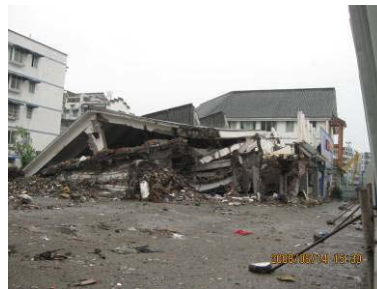
Collapse of a RC frame with a heavy roof, Dujiangyan

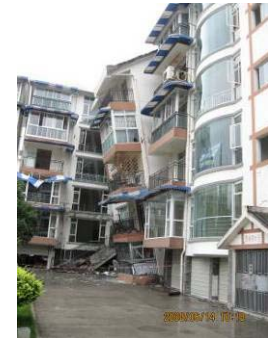
Weak story collapse of a RC frame

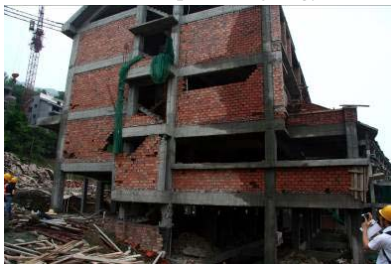
Shear failure of short columns in a split-level RC frames

The damage of most of the buildings with RC frame structures was not very severe in the earthquake. The damage mainly occurred in the enclosure structures and filler walls, especially circular filler walls. Such nonstructural damage also brings considerable economic loss and is even harmful to people's safety. Some RC frames collapsed in the earthquake due to poor construction quality or badly-designed structural system. The expected "strong column-weak beam" damage mode can be seldom found in the real damage, which may be the result of disregarding the strengthening effect of floor slabs and filler walls when the RC beams are designed. Figure 4 shows some typical damage in RC frames, including the shear failure of short frame columns in split-level buildings.

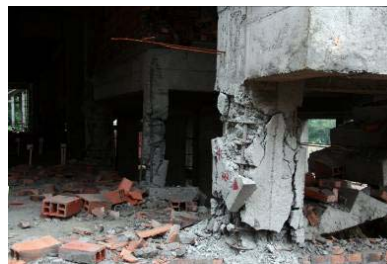
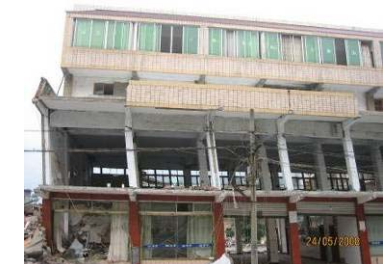
Fig. 4 Seismic damage in frame structures

Plastic hinges in frame columns, Nanba

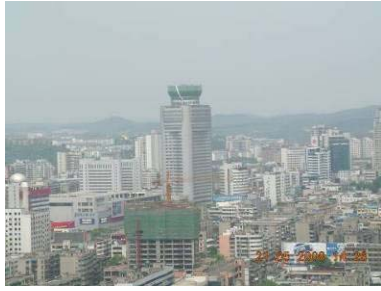
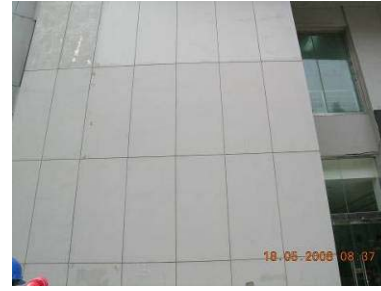
Fig. 5 Xinyi Building in Mianyang

This type of structure shows its advantage in seismic behavior in the earthquake. The damage of buildings with RC frame-shearwall (core tube) structures is very slight compared with that of nearby buildings with pure RC frame or other structures. Figure 5 is Xinyi Building in Mianyang city. Only some minor cracks were found in its enclosure walls in the earthquake survey.

(No damage in load-bearing structure. Only small cracks in some enclosure structures )

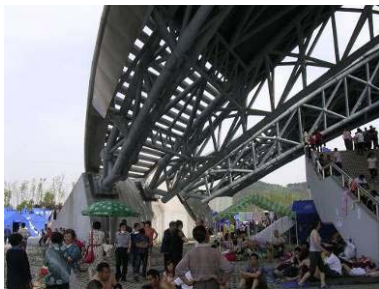
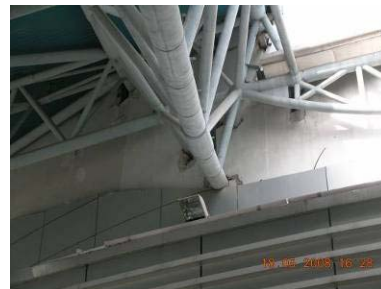
Fig. 6 Mianyang Jiuzhou Stadium

The damage of this kind of structures was very slight and occurred mainly in the enclosure structures. Figure 6 shows the Jiuzhou Stadium in Mianyang city. No damage was found in its major steel structure and concrete supports. Only some damage due to collision was found in the connections between the steel truss and enclosure walls.

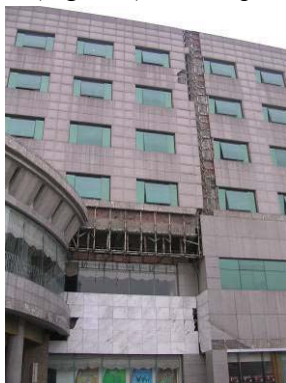
Some other typical damage was found in the earthquake area including damage due to the collision in expansion joints (Figure 8) and whiplash effect (Figure 9).

A hotel in Mianyang

Fig. Collision damage in expansion joints

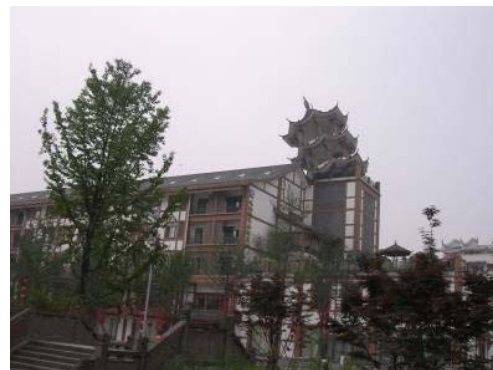
A public building in Dujiangyan

Fig. 9 Rooftop projection structural damage due to whiplash effect

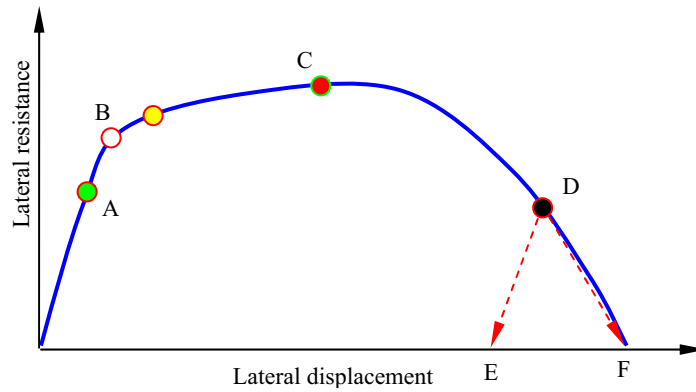
The seismic behavior of a structure under earthquake is demonstrated as the lateral resistance to displacement curve in Figure 11. Point B indicates the effective yielding point, where the stiffness of the whole structure decreases greatly. Point D is referred as “collapse point” where the structural status changes to collapse. It is defined as such a critical point that before this point the structure can stand itself and its elastic deformation can recover if the lateral load disappears, as the path from point D to point E shown in Figure 11, but beyond this point, the lateral deformation will go on increasing due to its self weight even if the lateral load disappears, as the path from D to F in Figure 11.

Fig 11 Lateral-load resistant behavior of structures

In Phase I, buildings are designed against minor earthquake, which is about 1/3 of the design earthquake. The structure is required not to yield under the minor earthquake with a certain safety margin. A design point demonstrated as Point A in Figure 11 is specified in the codes considering the structural safety margin and possible influence of randomness. In this phase, the safety margin of the whole structure is determined by that of each element, and is numerically equal to the smallest strength safety margin of all its elements. So it can be called “fundamental strength safety margin”, which can be demonstrated as the curve between point A and B in Figure 11. It is to ensure the safety and serviceability of building structural systems during their normal operation.

In Phase II, buildings are designed against severe earthquake, whose intensity is twice of the design earthquake. Collapse prevention is the main task for this phase. Another design point before the collapse point D in Figure 11 (e.g. point C) should be carefully specified. In the current Chinese code, this design point is defined by a maximal elastic-plastic story drift for high-rise or very important building structures. For example, the maximal story drift is 1/50 of the story height for RC frame structures and high-rise steel structures. In this phase, the structural system behaves as a whole. Parts of the structure yield or even fail. The safety margin of the whole structure is related but not equal to that of its elements. It is determined by the strength, ductility, energy-dissipating capacity of all its elements and their organization. In this sense, the safety margin in Phase II can be called “integrated safety margin”, which corresponds to the curve between point B and C in Figure 11.

There should be a third phase regarding the portion between point C and D in Figure 11 since buildings are also vulnerable to unexpected violent earthquake. So far, it’s almost impossible to determine and predict the structural behavior within this phase. But the structural safety margin between point C and D is of key importance to prevent building collapse and to save people’s lives. We call it “unexpected safety margin”, which is believed to be strongly related with the robustness, integral stability and integral firmness of structural systems. Researches on these topics are still very limited.

To improve the current seismic design method for preventing building collapse, more effort should be devoted to better understanding the structural behavior between point C and D in Figure 11. In the Sichuan earthquake, a lot of buildings are severely damaged, whose deformations are larger than point C defined in the design code, but did not collapse. Hence, there are actually many different states between severely damaged and collapse. Figure 12 shows some examples. These buildings are all severely damaged and beyond the design point against severe earthquake in the code. However, many of them are still standing, which may save a lot of people’s lives. To this end, methods to increase the robustness, integral stability and integral firmness

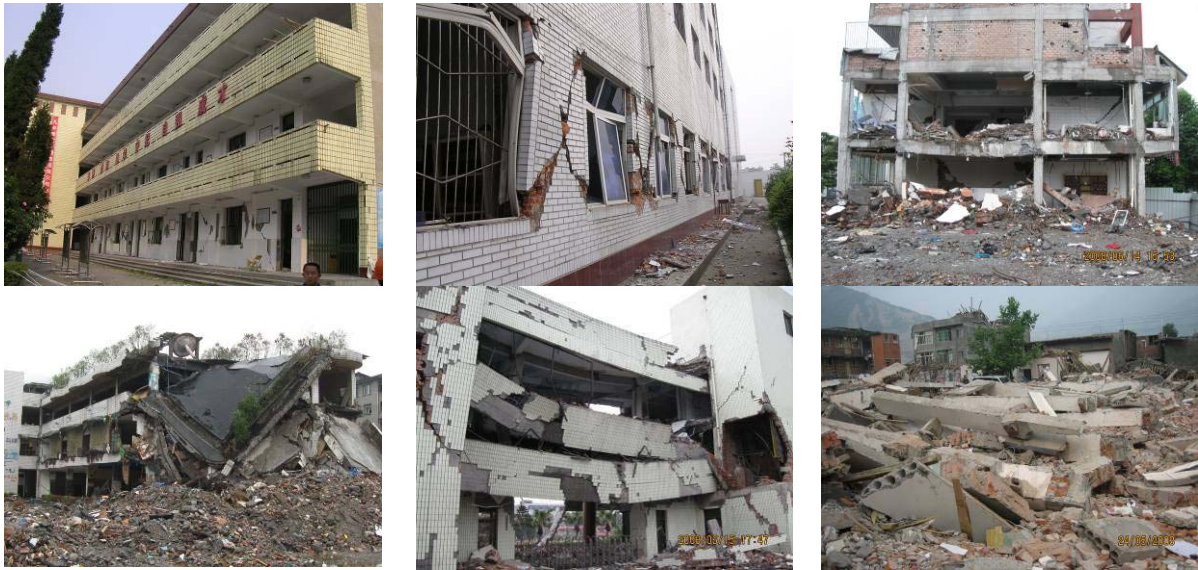
Fig 12 Different states of building damages beyond the design point against severe earthquake
