## Seismic retrofit of existing SRC frame using rocking walls and steel dampers

**Abstract:** A retrofit of an existing 11-story steel reinforced concrete frame that features the innovative use of post-tensioned rocking walls and shear steel dampers is presented. The main components of the retrofitting plan and important design considerations are described. The retrofitting system is expected to effectively control the deformation pattern of the existing structure and significantly reduce damage to the existing structure during major earthquakes.

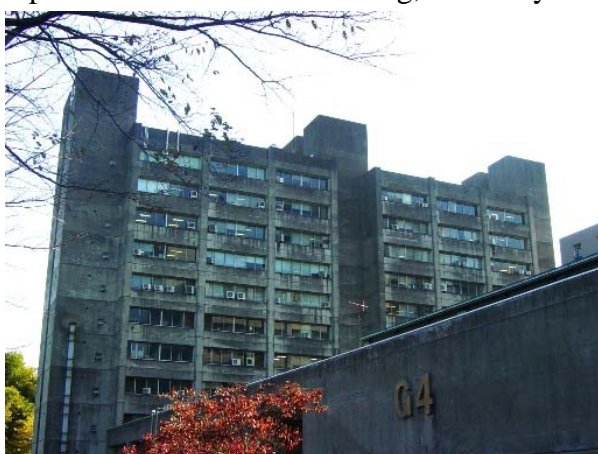
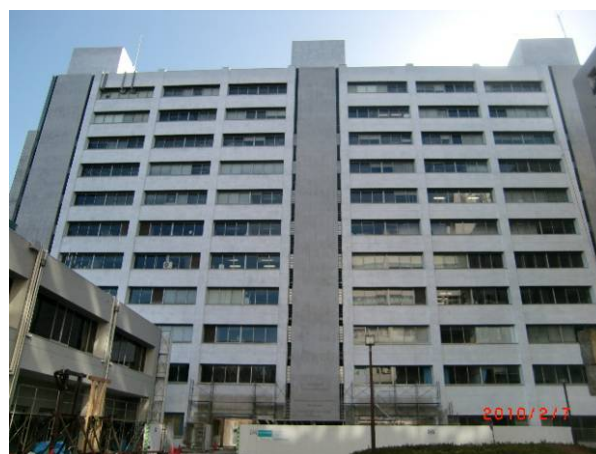
(a) Existing

(b) Retrofitted

Figure 2 The north views of G3 Building before and after the retrofit

The G3 Building is an 11-story steel reinforced concrete frame structure on the Suzukakedai campus of the Tokyo Institute of Technology in Japan (Fig. 2(a)). As mentioned above, it was designed and constructed before the major revision of the seismic code of Japan and it has already been occupied for more 30 years. As concluded by a recent seismic inspection, there is an urgent need to strengthen the structure, especially in its longitudinal direction.

Figure 2(b) shows the north view of the retrofitted G3 Building. During the retrofit, the building remained occupied because most of the construction was done from outside the building. Figure 3 shows the structural plan of the G3 Building before and after retrofitting. There are several other multi-story concrete buildings on the same campus with similar configurations to that of the G3 Building. A common feature is that there are several slots along the perimeter of the building. This feature makes it easier to implement the rocking wall system. For the G3 Building, 6 pieces of post-tensioned concrete walls with pin bearings at the bottom were installed in the existing slots and firmly connected to the existing frame at each floor level by horizontal trusses. Shear steel dampers were installed in the gaps between the rocking walls and adjacent existing SRC columns as well as between the rocking walls and the added transverse walls at both ends. Main components of the rocking wall system, i.e. the post-tensioned concrete walls, the steel dampers, and the bottom pin bearings, are visible from outside the building; thus people can see them and appreciate the engineering solution.

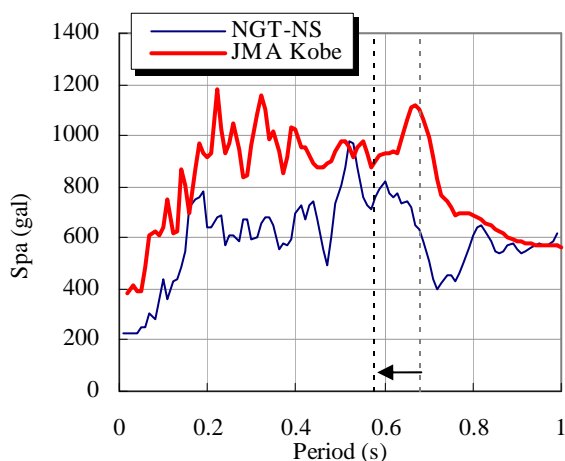
Figure 11 Response spectra of the selected ground motion records

The pseudo acceleration response spectra of the two records are shown in Figure 11, where the fundamental periods of the structural models before and after the retrofit were 0.68s and 0.58s, respectively.

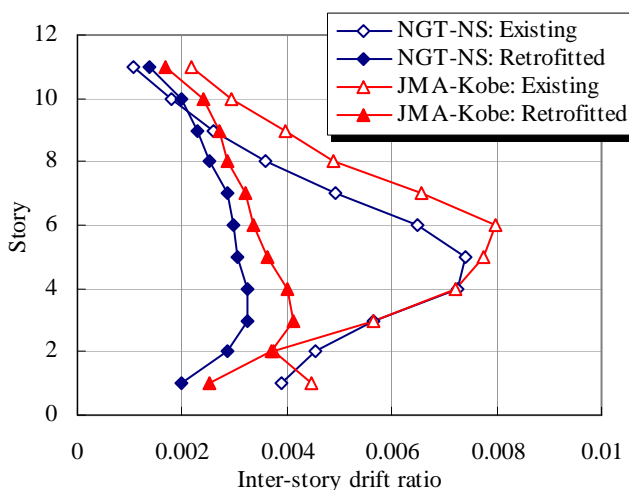
Figure 12 Story drift ratios of the structure before and after the retrofit

Two-dimensional member-by-member finite element models are built in ABAQUS 6.8. A fiber-based beam element is used to model the existing SRC frame, and user-defined uniaxial materials were used for concrete fibers and steel fibers. The behavior of the steel dampers was idealized as an elastic-perfectly plastic model, and the rocking walls were assumed to remain elastic through the analysis. The maximum story drift ratios of the structure before and after the retrofit under the above ground motions are shown in Figure 12. It is obvious that the deformation of the structure is significantly reduced and is below the 1/200 criteria under both ground motions after being retrofitted. Furthermore, the deformations in different stories are much more evenly distributed along the height of the structure, which indicates that the damage is spread throughout the structure so that excessive damage is not concentrated in a local part of the structure, which could cause premature failure of the whole structure.
